HWY-05-M-H035
Wilmer, Texas

Forensic Tire Report - Bridgestone/Firestone

VEHICLE FACTORS: TIRES AND TIRE MARKS

Description: Motorcoach Fire
Location: I-45 Near Wilmer, Dallas Co., Texas
Date: September 23, 2005
NTSB Case No.: HWY-05-MH-035

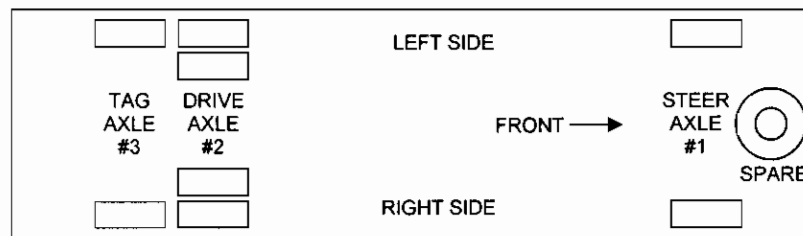
Figure 23: Motorcoach Tire Positions

Axle*	Left Side	Right Side
1	Consistent with Dayton Rib Radial All Position 11R22.5 Load Range G	Dayton Rib Radial All Position 11R22.5 Load Range G
2	Both tires consistent with Firestone FS400 315/80R22.5	Both tires consistent with Firestone FS400 315/80R22.5
3	Consistent with Firestone FS400 315/80R22.5	(not present) See Note 1
Spare	Firestone FS400 315/80R22.5 Load Range J See Note 2
